**CITY OF BORDENTOWN
WATER DEPARTMENT**

ASSET MANAGEMENT PLAN

APRIL 2019

RVE PROJECT NO. 0313T017

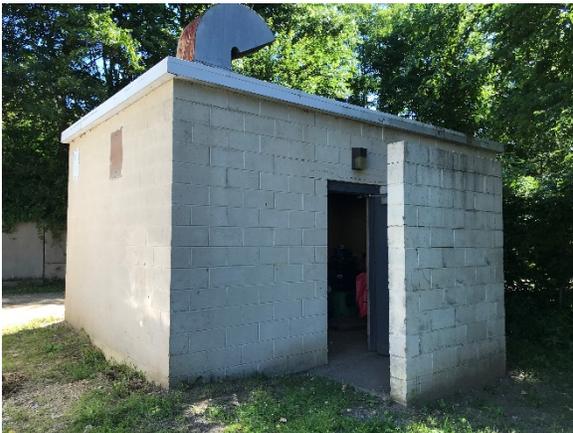
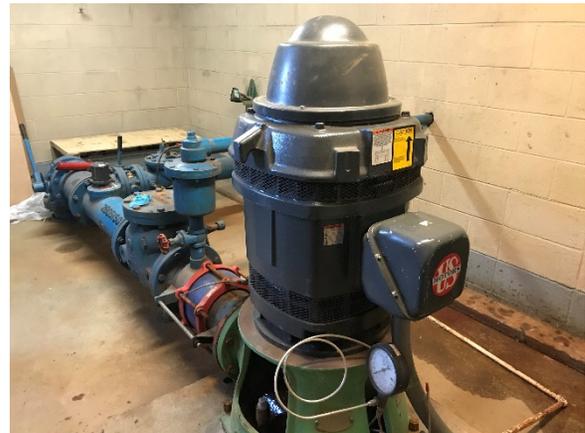
2.1.3 Well #1

Well #1 is located closest to the water treatment plant at the facility. The well was originally constructed in 1964 and is 126 feet deep. The well is permitted for 800 gpm and includes a vertical turbine pump operated with a 40 horsepower premium-efficient motor. The last redevelopment of the well and well pump rehabilitation was performed in 2015. No issues were reported with the pumping equipment. The electrical equipment was in newer condition, having been replaced in the last few years. The control equipment appears to be in fair condition, with no issues noted by the operator. Due to the age of the well as compared to others on site that have been replaced, this well should be considered for replacement in the next 10 years.

The building is in fair condition, with a few cracks visible in the CMU block walls. No condensation issues were noted during our inspection, but water from the discharge head was accumulating on the floor nearby. The water from the discharge head should be piped to a drain or outside the building to prevent high humidity levels within the building. High humidity levels can cause corrosion and damage to electrical equipment. Since our site visit, the drain piping was addressed to remove the standing water within the well house.

Well #1 Replacement	Well #1 is the oldest of the wells on site and the only one on this site which hasn't been replaced, or in an urgent need for replacement. Well #1 should be replaced before it fails in order to maintain capacity of the facility.
Lagoon Cleanup	The lagoon is required to be cleaned up over the next several years as mandated by an administrative consent order from the NJDEP. In 2019, the Water Utility will work with NJDEP to close the lagoon.

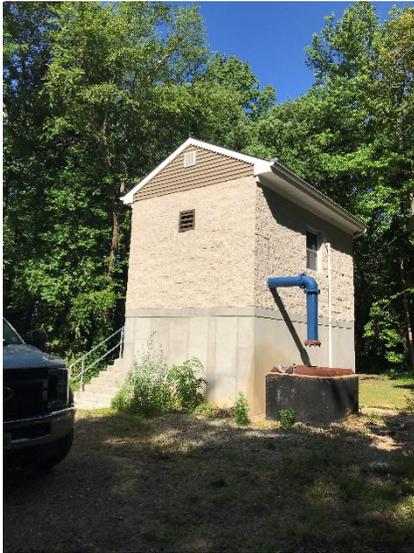
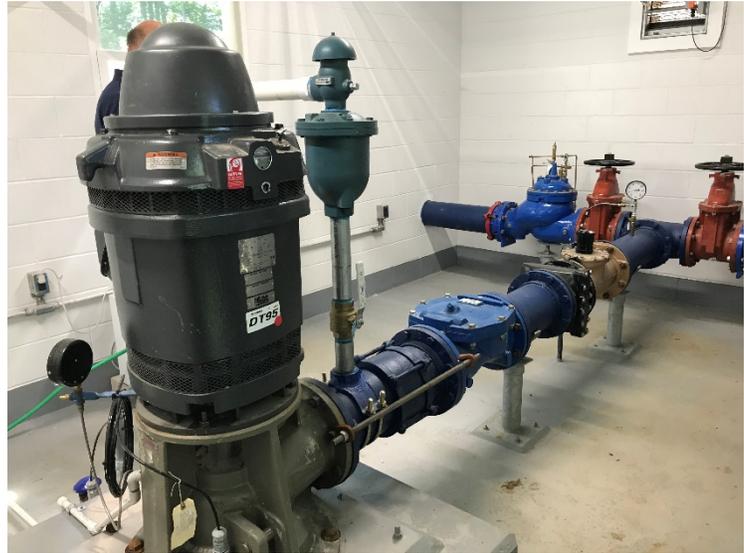
2.1.4 Well #2A

Well #2 is located at the rear of the site, furthest from the water treatment plant. The well was recently constructed in 2016 and is 198 feet deep. The well is permitted for 1000 gpm and contains a new vertical turbine pump with a 60 horsepower premium-efficient motor installed during the well installation project. Some turbidity issues were noted soon after installation but has since cleared upon further pumping. The well is operated in a rotation with the other two operable wells. The electrical and control equipment is new and in good condition.

The building is in good condition, having been installed following the well installation in 2016. No condensation or accumulating water issues were noticed during the inspection, however, the well was not used on a consistent basis prior to our site visit. The interior of the well house should be monitored for any condensation or accumulating water as part of the existing operations and maintenance plan.

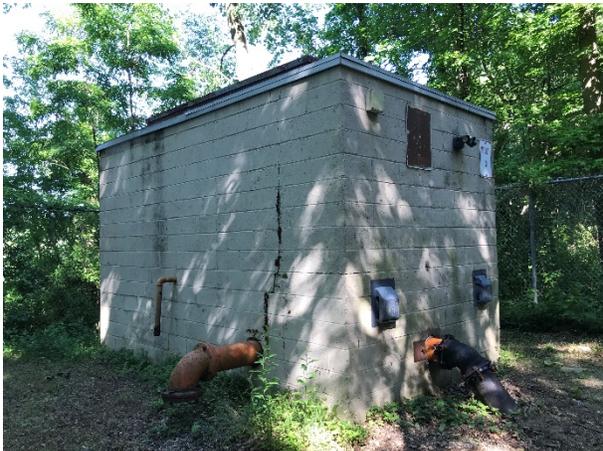
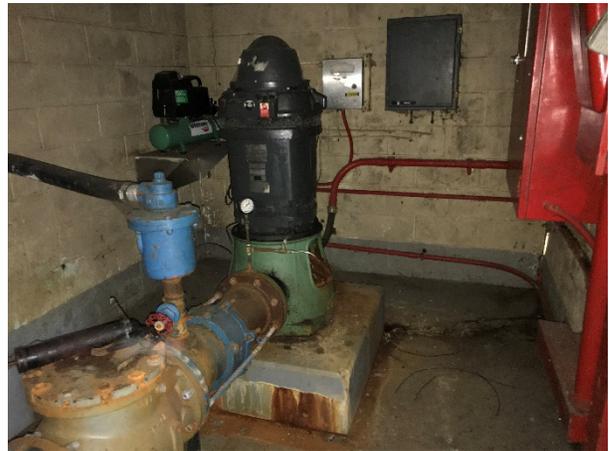
2.1.5 Well #3 Facility

Well #3 is remotely located from the water treatment plant. The well was originally constructed in 1965 and is 140 feet deep. The well is permitted for 1100 gpm. The last redevelopment of the well and well pump rehabilitation was performed over ten years ago. The electrical and control equipment appears to be older, but in fair condition, with no issues noted by the operator.

The well has been offline for the last two years due to damage to the well building. The back of the building, containing the well, appears to be sinking into the ground. The well and well building should be replaced as part of a capital improvement plan. Replacement of the well will allow all of the Water Utility's wells to operate at full capacity.

ASSET	RISK SCORE	SUMMARY
Well #3 Replacement	15	Well #3 is inoperable due to settlement of the well house around the well. Due to its age and the replacement of other wells on site, Well #3 should be replaced to ensure full capacity of the facility.
Crosswicks Road Tank	14	The 4MG tank has not been painted since 2000. The tank is overdue for painting on the interior and exterior and corrosion is evident on the exterior. Corrosion will continue and worsen the longer the tank is left unpainted.
Gilder Park Tank	13.5	The 800,000 tank has not been painted since 2000. The tank is overdue for painting on the interior and exterior and corrosion is evident on the exterior near the bottom. The tank should be painted to maintain its current condition.
WTP Air Strippers	13.5	The air strippers have been in place for approximately 20 years. Water was seen leaking from the blowers during our inspection. The air strippers are due for service, including replacement of the blowers, to ensure full capacity.

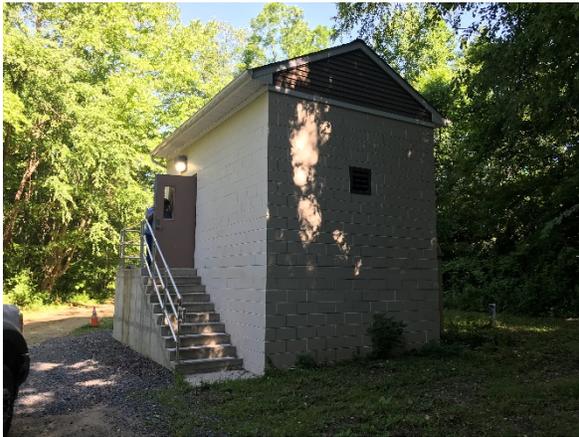
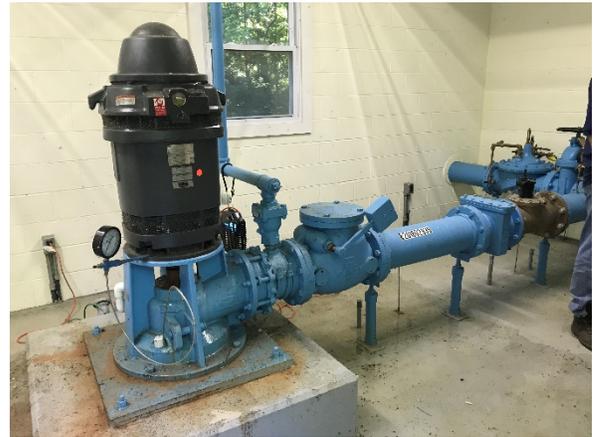
2.1.6 Well #5R Facility

Well #5R is located between Well #3 and Well #1 on the site. The well was recently constructed in 2015 and is 200 feet deep. The well is permitted for 1000 gpm and contains a new vertical turbine pump with a 60 horsepower premium-efficient motor installed during the well installation project. The electrical and control equipment is new and in good condition. The operator indicated no issues with the well and pumping equipment.

The well building is new and in good condition. However, water was accumulating on the floor near the well during our inspection. The discharge head did not appear to be draining properly and was leaking to the floor. The drain piping should be repaired or replaced to prevent water accumulation and subsequent damage to interior components. Since our site visit, the drain piping was addressed and dehumidifiers were placed into operation to remove the standing water and high humidity within the well house.

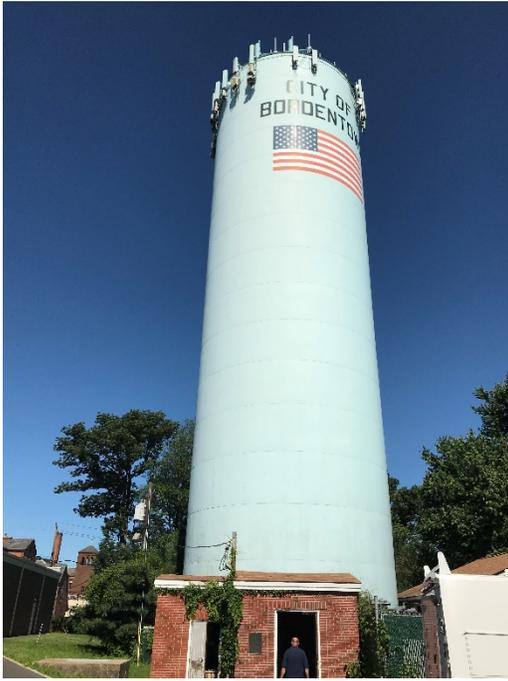
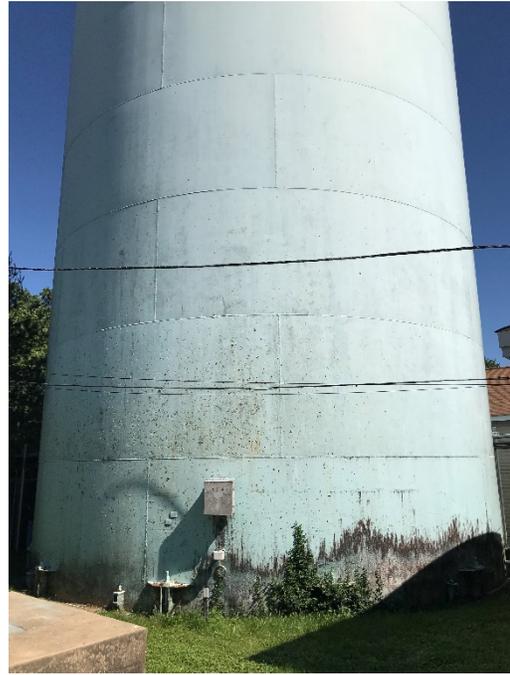
2.1.7 Water Storage Tank – Gilder Park

The water storage tank at Gilder Park is located off of Crosswicks Street near Route 130. The welded steel tank was constructed in 1956 and has a capacity of 800,000 gallons. The tank interior and exterior was last painted approximately 14 years ago. Based on the recommended maintenance schedule of repainting every 10-15 years, the tank should be scheduled for repainting as part of a capital improvement plan.

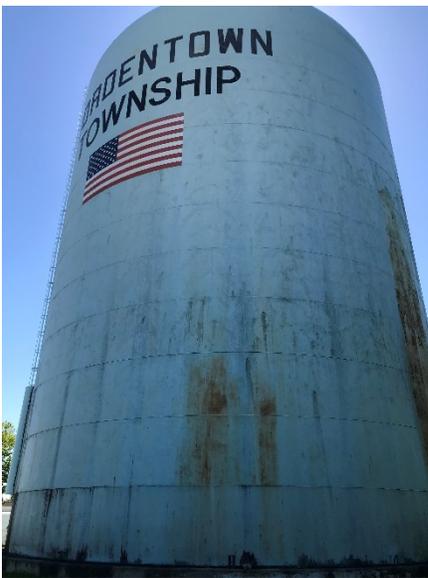
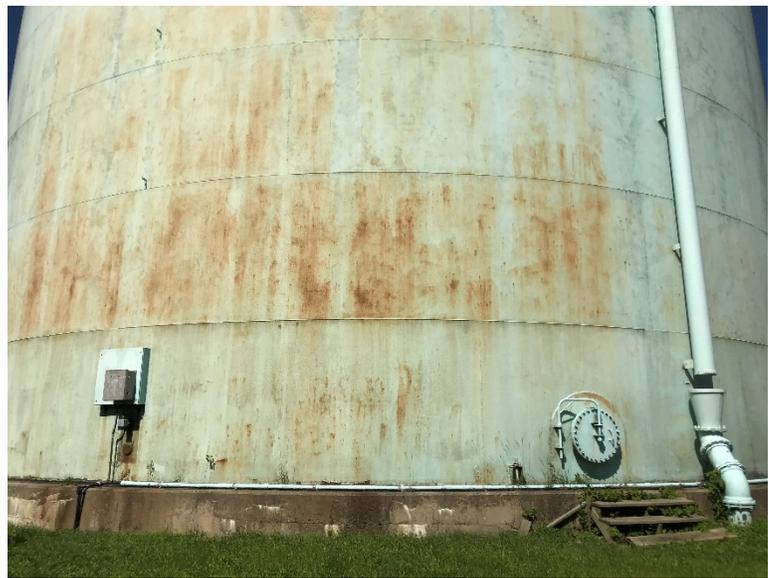
2.1.8 Water Storage Tank – Crosswicks Street

The Crosswicks water storage tank is located on Crosswicks Street adjacent to the Public Works facility, which is approximately $\frac{3}{4}$ of a mile to the East of the Gilder Park Tank. The welded steel tank was constructed in 1984 and has a capacity of 4 million gallons. The tank interior and exterior were last painted approximately 14 years ago. Based on a tank repainting schedule of every 10 to 15 years, the tank should be re-painted in the near future as part of a capital improvement plan in order to preserve and extend the life of the tank.

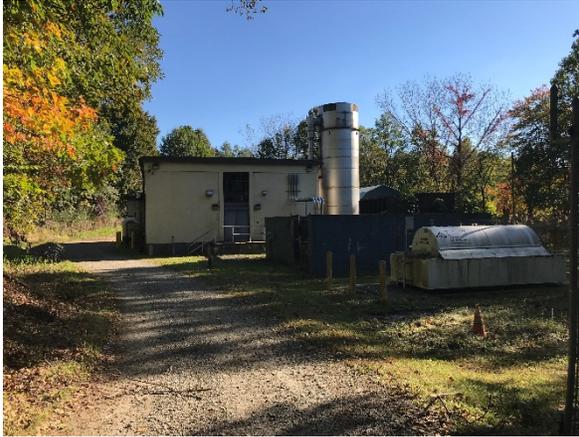
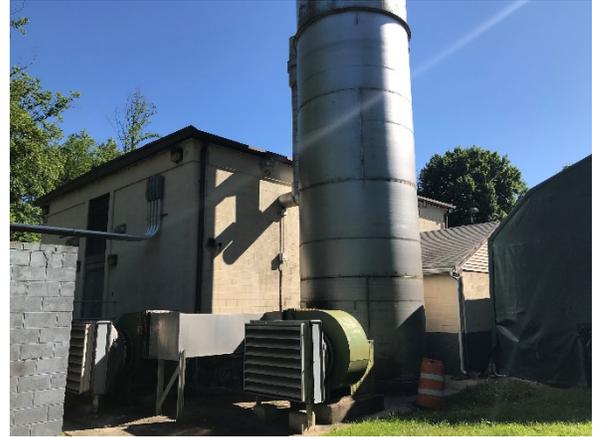
2.1.9 Water Treatment Plant

The water treatment plant is located off of Route 206 near its intersection with Interstate 195. All of the wells on the site pump to the plant for treatment prior to distribution. Treatment at the facility includes radium removal, air stripping, iron sequestering, pH adjustment, and chlorination. Three (3) high service pumps are used to pump the treated water into the distribution system

Upon entering the water treatment plant, the raw water is conveyed through six (6) adsorption vessels containing radium removal media. The tanks have been in place since installation of the plant in 1973, but have been maintained and are in fair condition. The radium removal media was installed in 2016 and is maintained by Water Remediation Technology, LLC (WRT). With all filters operational, the filters can handle up 2800 GPM. As with the vessels, the vessel piping and valves appear to be in fair condition, with no issues indicated by the operator.

Following the radium removal equipment, the water is treated with lime to raise the pH of the water before being conveyed through the air stripper for treatment of volatile organic compounds (VOCs). The lime treatment equipment has recently been installed and is in good condition. The air stripper is approximately 20 years old. The blowers for the air stripper were leaking water through holes corroded through the metal casing. The air stripper should be inspected and serviced as required. The blowers should be scheduled for replacement to ensure proper operation and treatment.

After the air stripper, the water is fed into an underground clearwell for storage and detention time prior to being pumped into the distribution system. The water is sent into the distribution system by three (3) high service pumps located in the basement of the treatment plant. Two of the three pumps are original to the building, in 1973, and in fair condition for their age. However, the pumps are past their expected service

lives and should be serviced to prevent sudden failures. The third pump was replaced in 2010 and was in good condition.

The electrical and control equipment for the treatment plant are in good condition, with a new installation completed in 2018. The well pumps, high service pumps, and water tanks are monitored and controlled by a new SCADA system. A generator, located at the water treatment plant, provides backup power to the water treatment plant and wells. The generator is rated for 600 kW and was installed approximately 10 years ago. The generator appeared to be in good condition.
